#### Libby Asbestos Superfund Site Operable Unit 3 (OU3) Ecological Risk Assessment

## Briefing for Carol Campbell, Acting Deputy Regional Administrator January 7, 2010

Purpose: Briefing is informational only. Focus is the ecological risk assessment for Libby OU3.

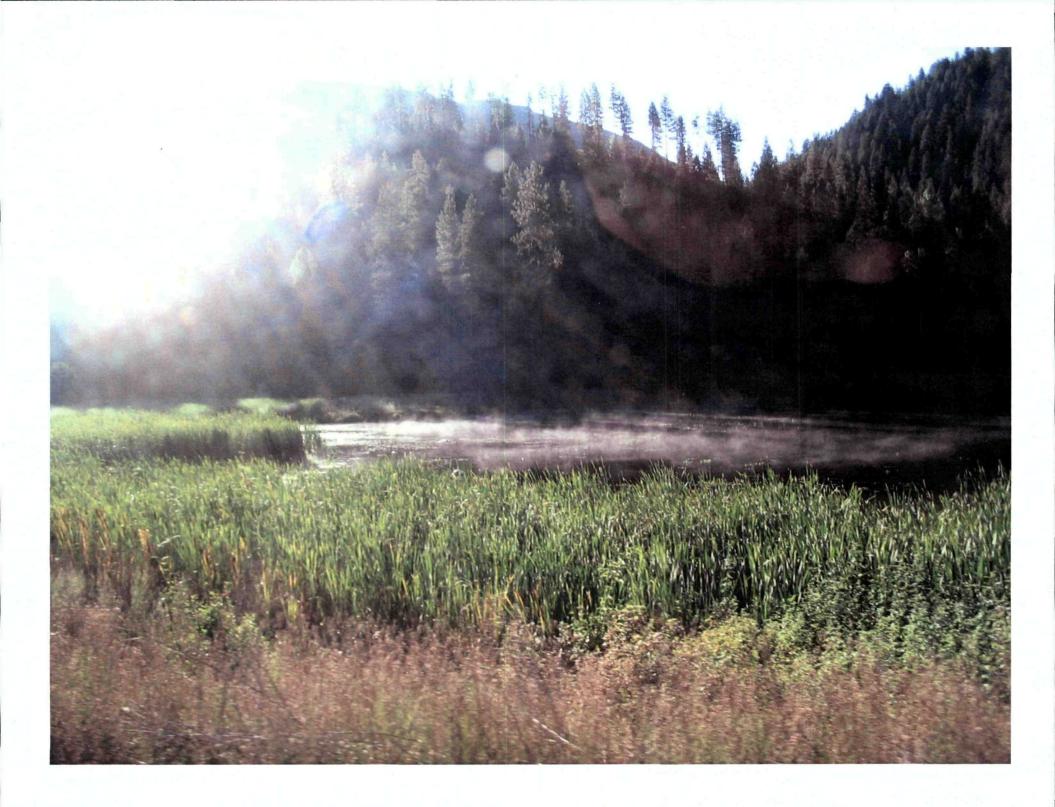
- First Ecological Risk Assessment with asbestos (ever?)
- Sparse exposure and effects information
- Sparse fate and transport information
- Important route(s) of exposure largely unknown
- Sensitive species unknown
- Relevance of LA toxicity to population level effects unknown
  - Latency??
- Typical tools unavailable or need development
